# Manhole Inspection Summary

Manhole # S43II\_034MH

**Inspection** ☐ Is Incomplete Rating: **4) Poor**

**Location** Address: **1602 BETHEL ST**

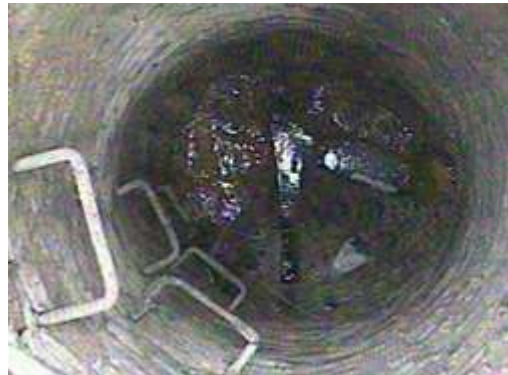
Top View

Condition: ☐ Sound ☐ Cracked ☐ Root Intrusion ☐ Deteriorated ☐ Leaks ☒ **Debris**

debris on bench

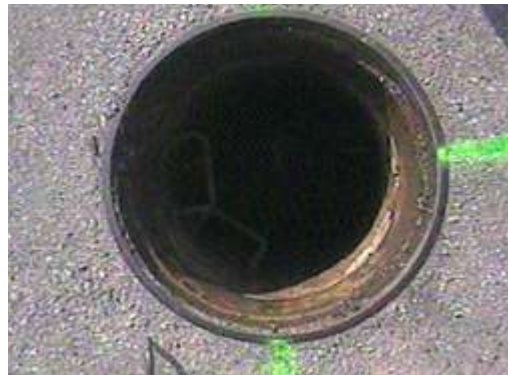
Defect 2

Count: **8** Missing: **0** ☒ **Corroded**

corroded steps

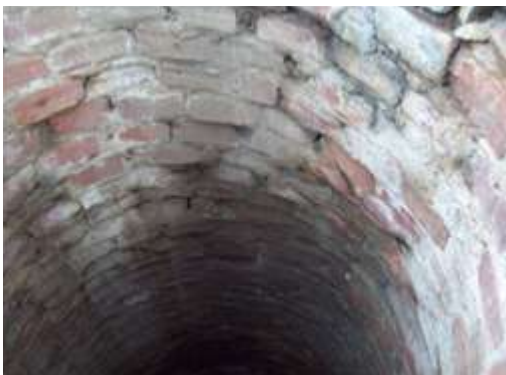
Defect 1

Infiltration: ☐ None ☐ Joint ☐ Cracks ☐ Mortar ☐ Roots ☒ **Wall**

Infiltration @ barrel

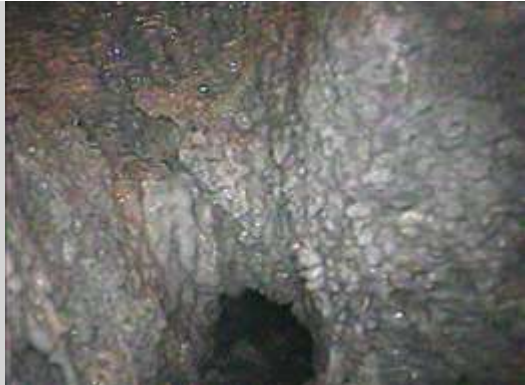
12 O'Clock Outflow

GREASE/SLUDGE ALL OVER CHANNEL

Deposits: ☐ None ☐ Mud ☒ **Sludge** ☐ Debris ☐ Grease

Silt Depth: **2** (in.) Deposits Extent: **Medium**

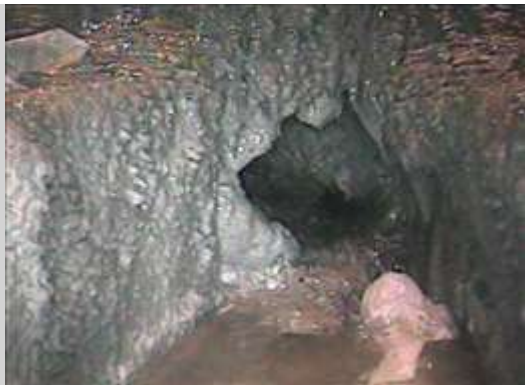
3 O'Clock Inflow

GREASE/SLUDGE ALL OVER CHANNEL

Deposits: ☐ None ☐ Mud ☒ **Sludge** ☐ Debris ☒ Grease

Silt Depth: **2** (in.) Deposits Extent: **Medium**

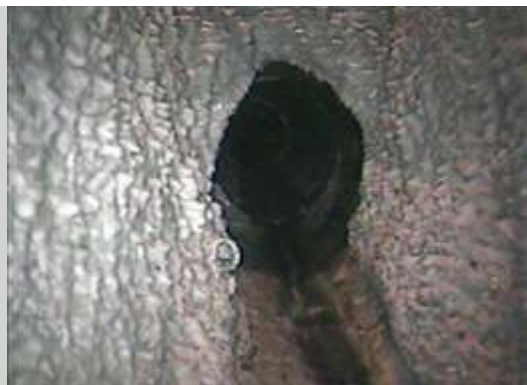
6 O'Clock Inflow

Deposits: ☐ None ☐ Mud ☒ **Sludge** ☐ Debris ☒ **Grease**

Silt Depth: **0** (in.) Deposits Extent: **Light**
